VEHICLE SPEED DETERMINATION FROM FUZZY EVIDENCE IN A MULTIPLE PEDESTRIAN COLLISION

Tim Stevenson and John Raine.

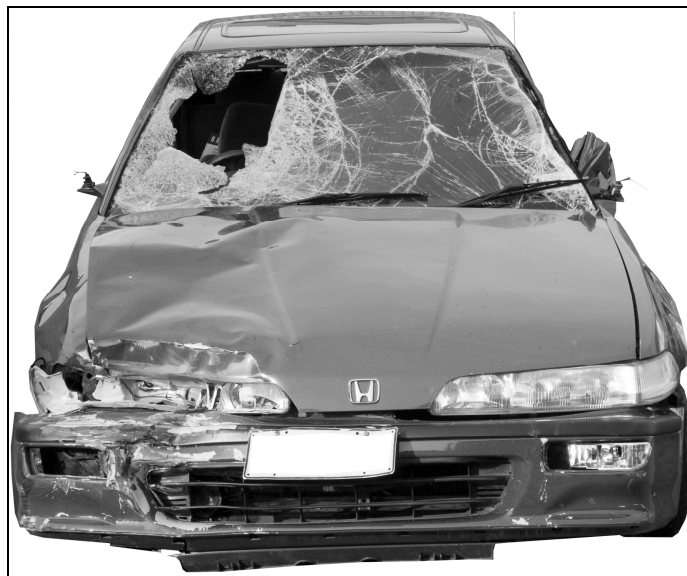
Figure 1: Honda Integra Vehicle Involved in Multiple Pedestrian Collision Incident

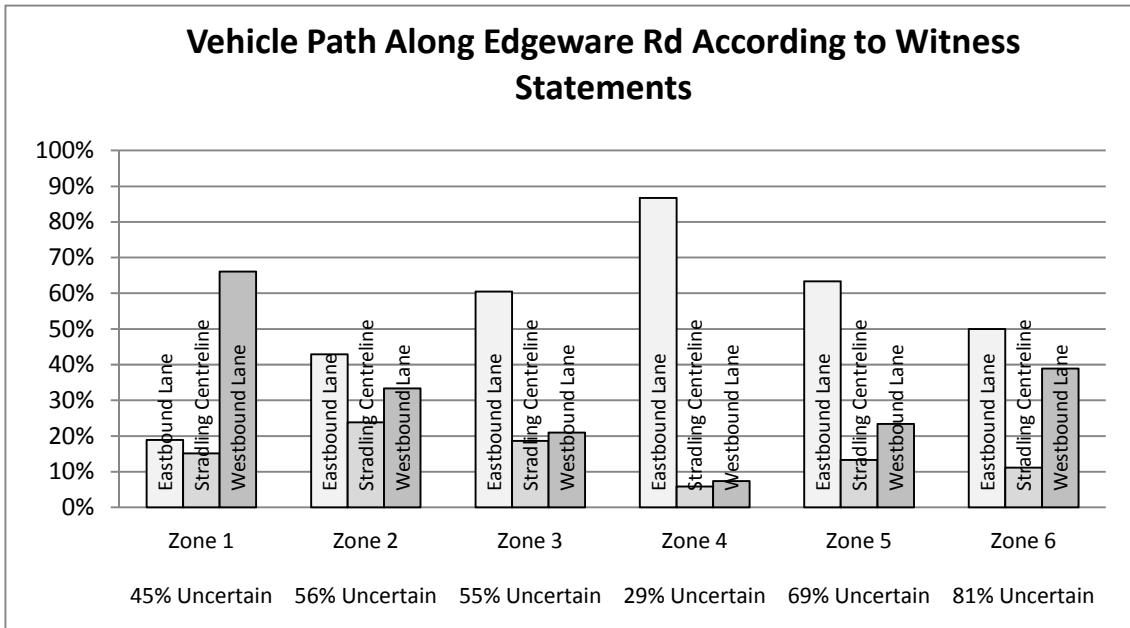
Not shown in the bar graph of Figure 7 but noted in the legend are the large number of 'Unknown, Uncertain or Unstated' responses that resulted from the method of analysis. If a witness provided a vehicle position indication for a single zone only, this created an 'Unknown, Uncertain or Unstated' entry in each of the other five zones. For example in zone 1, the data graphed represent 55% of the witnesses who gave statements that related to vehicle path. Only 11 of the 96 witness statements/diagrams analysed gave an indication of vehicle path/placement for all six zones. 57 out of the 96 witness statements/diagrams analysed failed to clearly indicate a perceived vehicle position/placement for four or more zones

Figure 7: Vehicle path along Edgware Road according to witness statements.

Figure 7 indicates that the Integra was most likely in the westbound lane in Zone 1, i.e. prior to the Manchester Street intersection. In Zone 2, opposite the Manchester Street intersection, it was likely that the Integra was changing lanes. For Zone 3, between the Manchester Street intersection and 95 Edgware Road the Integra was most likely in the eastbound lane (i.e. the wrong side of the road). For Zone 4, opposite 95 Edgware Road, most (61%) of the witnesses stated that the Integra was in the Eastbound lane. In Zone 5, opposite 93 Edgware Road, it appears that the Integra remained in the eastbound lane. In Zone 6, between 93 Edgware Road and the Cranford St intersection, there was no consensus on the vehicle's path from the witness statements. The Police plots of witness recollections of the vehicle path, **Figure 2**, support the bar graph representation of **Figure 7**.

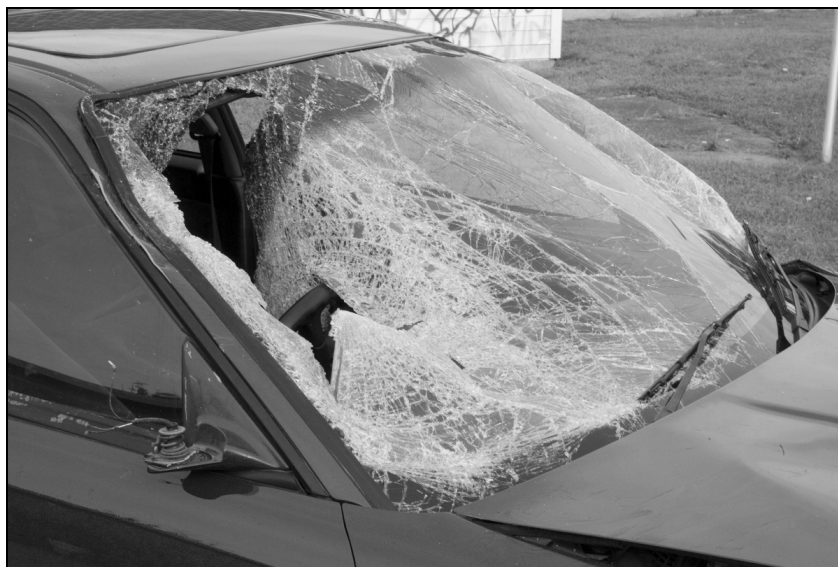
Significant penetration into the windscreen was evident, as shown in **Figure 9**. Mizuno and Kajzer [8] noted from impact tests a lack of penetration into windscreen for pedestrian head impacts of 50 km/h. However, multiple impacts on the windscreen may influence this result. It is also possible that the driver of the vehicle further damaged the windscreen in order to create an opening to see through after the pedestrian impacts.

Figure 9: Penetration into windscreen.

Taking only the location of the headstrike into account and not the severity of windscreen damage, the vehicle speed for the pedestrian impact causing windscreen headstrike in front of the driver was judged to have been in the vicinity of 70 km/h.

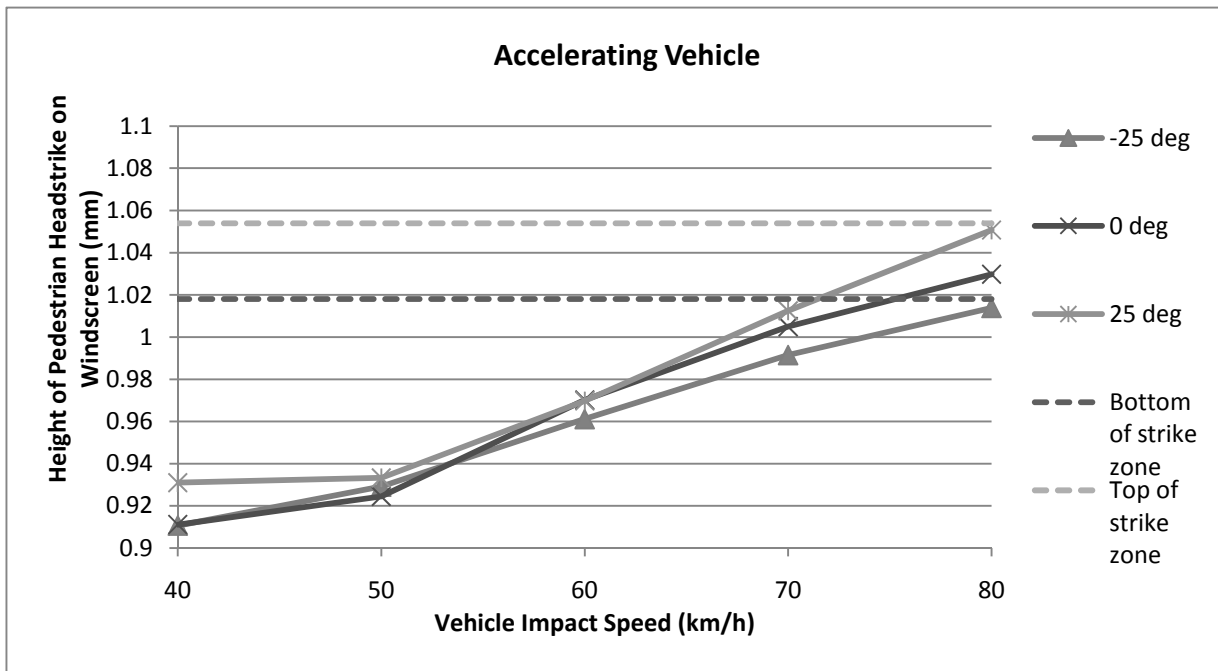
For an accelerating vehicle a minimum impact speed of approximately 72 km/h was required for a headstrike in the correct location, depending on the pedestrian's orientation. This is illustrated in **Figure 16**.

Figure 16: Headstrike height results for simulations using an accelerating vehicle.

With the deceased female having been struck from behind (per eye witness statements), and a headstrike in the correct area of the vehicle's windscreen, the computer simulation indicated a vehicle impact speed of at least 60 km/h for a vehicle travelling at constant speed, and in excess of 72 km/h for an accelerating vehicle.

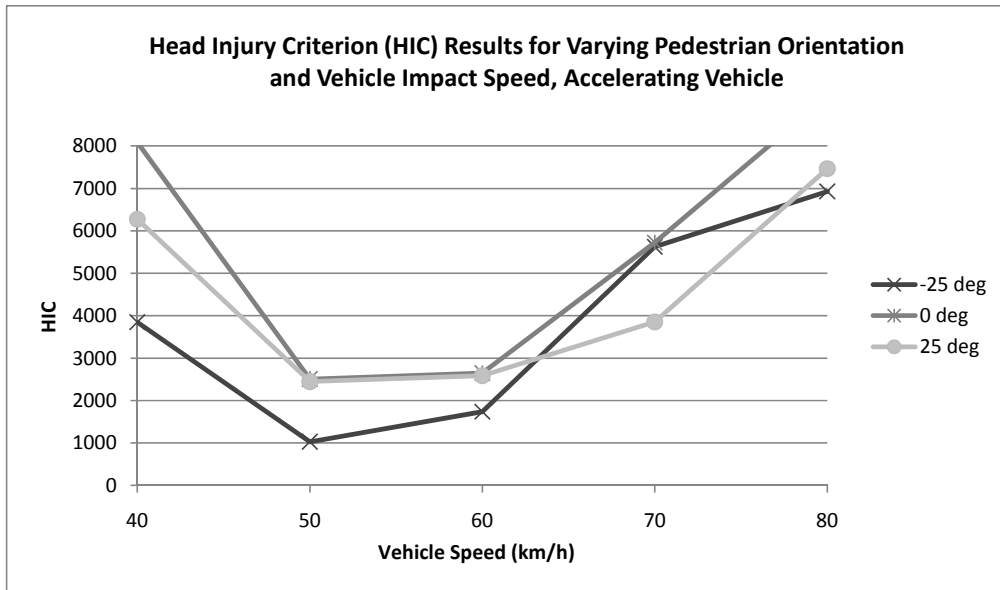
In the case of an accelerating vehicle the risk of serious head injury was noted to be much higher, as is evident in Figure 19. The high values obtained at 40 km/h resulted from the pedestrian's head striking the stiff area at the base of the windscreen. The simulations therefore confirmed the risk of serious head injury in vehicle-pedestrian collisions in all the scenarios simulated with the exception that modelling a vehicle travelling at a constant speed of 40 km/h.

Figure 19: Head Injury Criterion (HIC) results for accelerating vehicle impacts.
